PHOTODOCUMENTATION LOG SHEET
Turkey Brook Site • Oakville, Connecticut

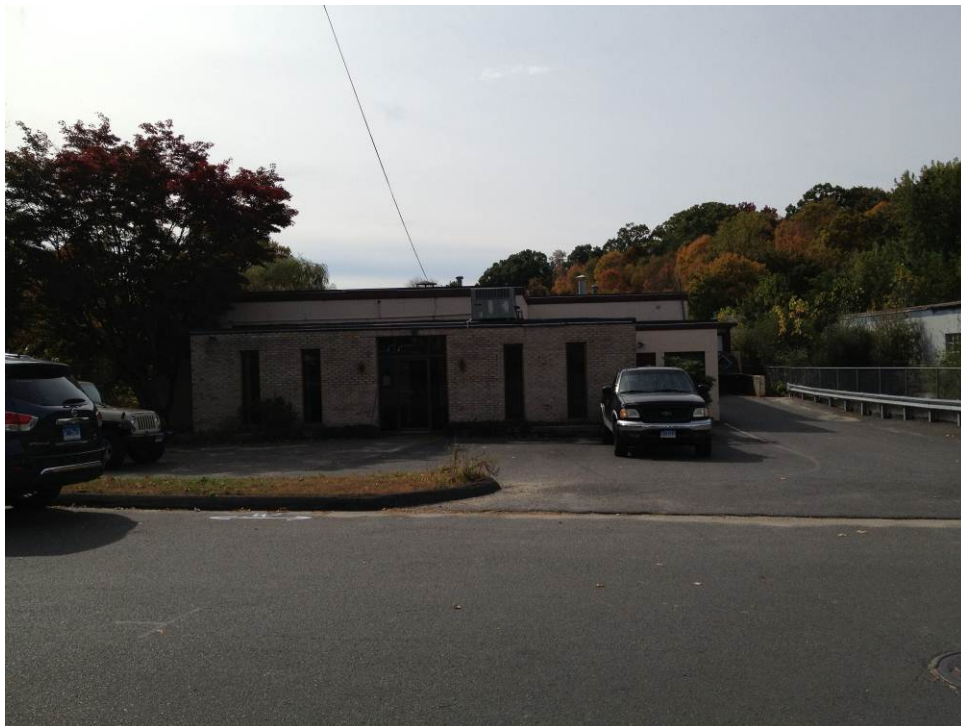
SCENE: View of Quality Automatics, Inc. facility located on south side of McLellan Drive (15 McClellan Drive). Photograph taken facing southwest.

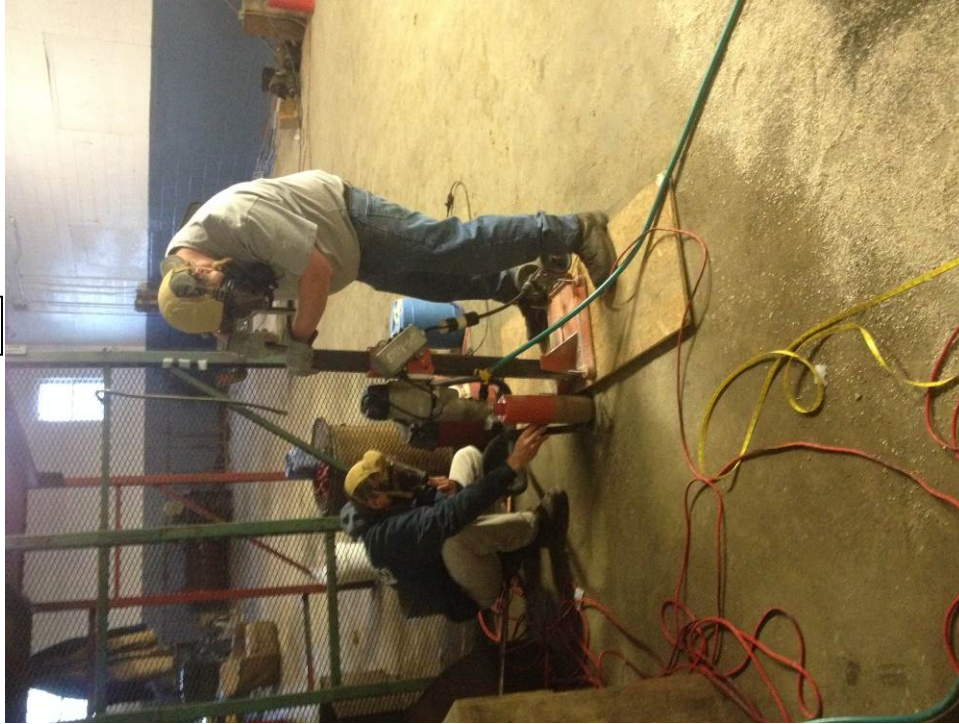
SCENE: View of personnel completing a soil boring inside the Quality Automatics, Inc. building (20 McClellan Drive).

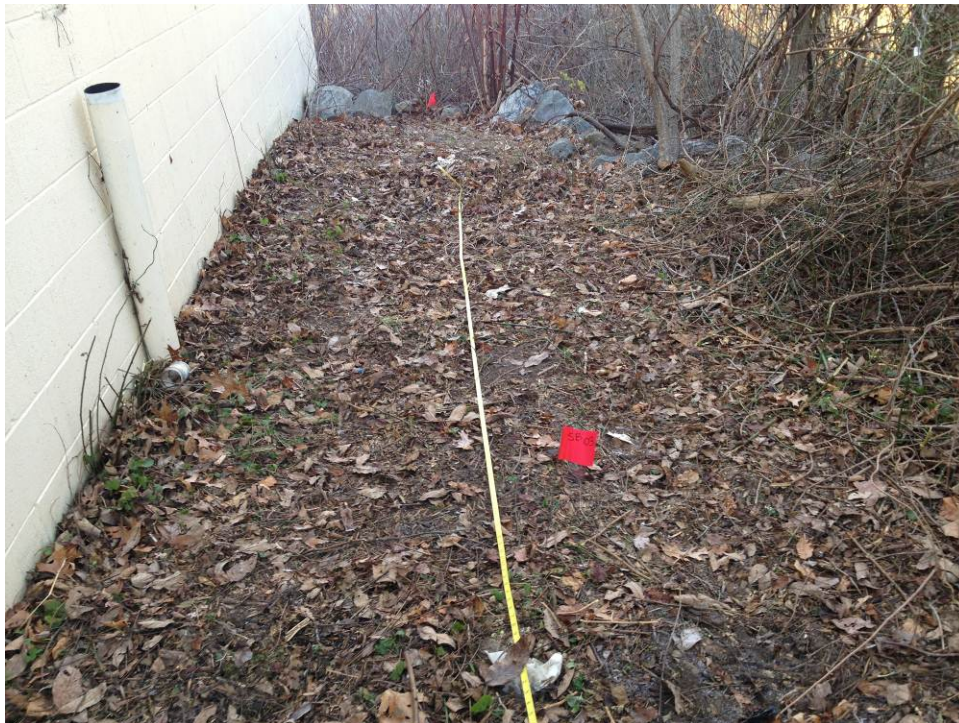
SCENE: View of soil boring locations SB-03 and SB-04 located on the northern side of the Quality Automatics, Inc. building (20 McClellan Drive). Photograph taken facing west.

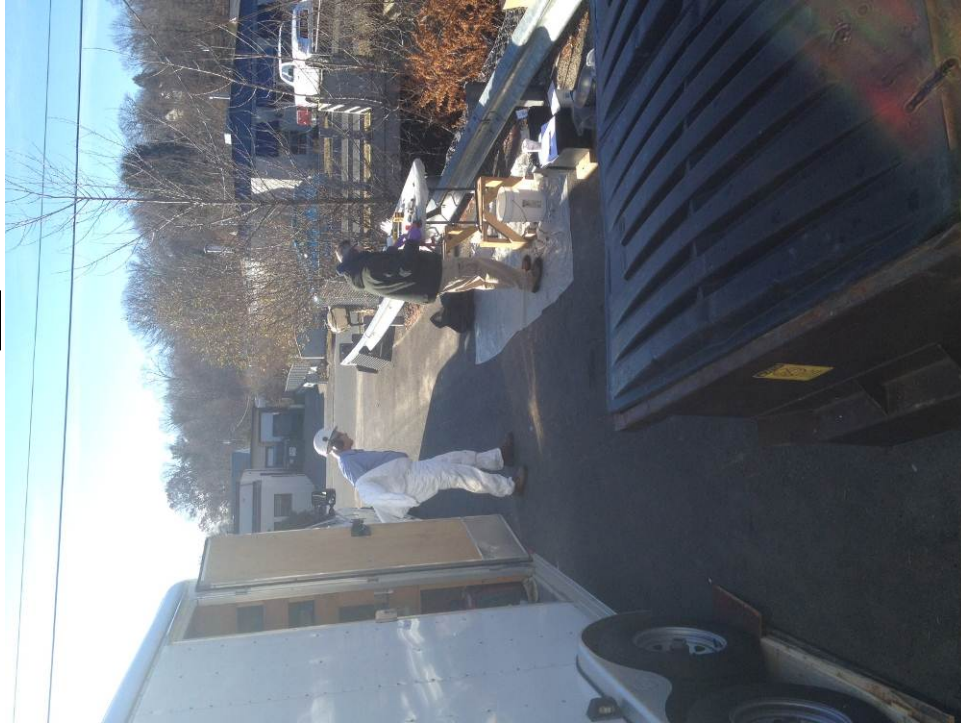
SCENE: View of the soil classification area.

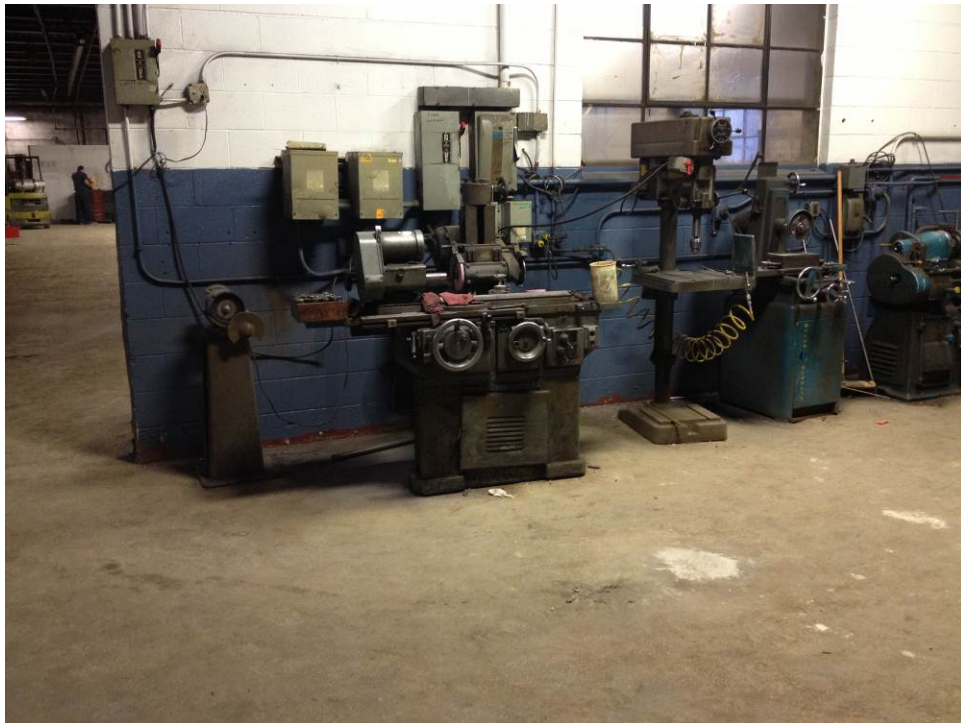
SCENE: View of soil boring location SBC-03 located inside of the Quality Automatics, Inc. building. Photograph taken facing south.

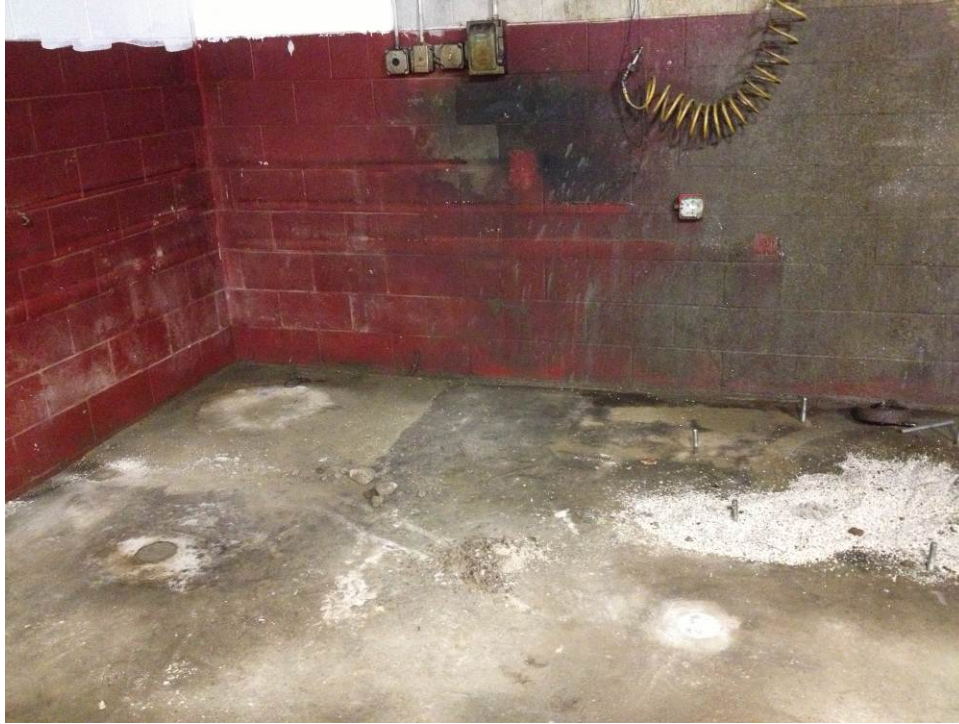
SCENE: View of soil boring locations SBC-07 and SBC-08, located inside of the Quality Automatics, Inc. building. Photograph taken facing north.

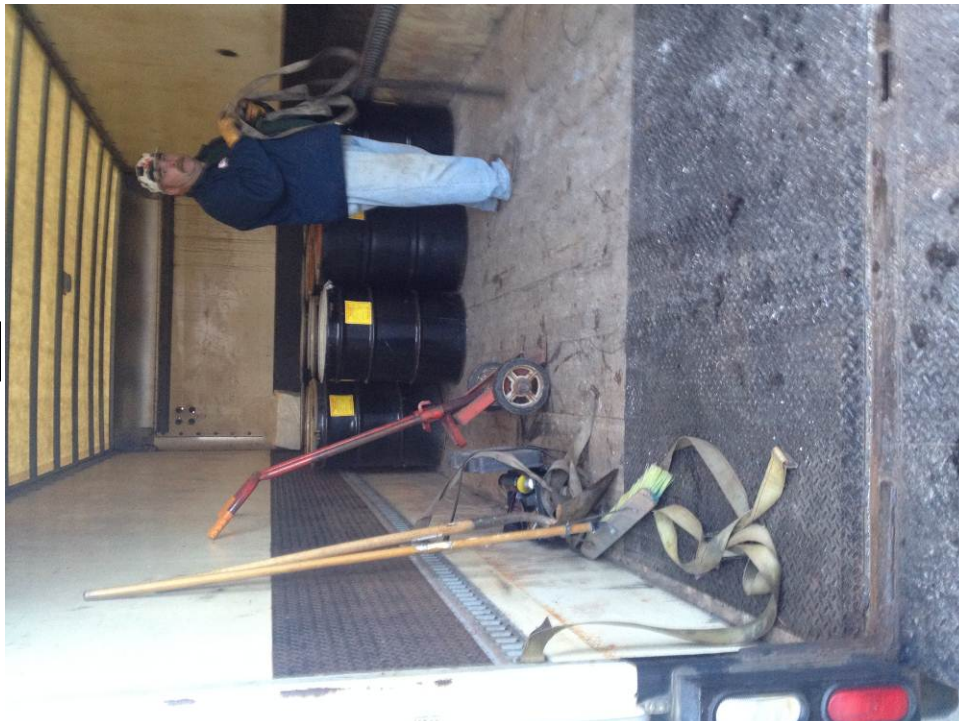
SCENE: View of the loaded drums containing petroleum waste being secured for transportation to the disposal facility.

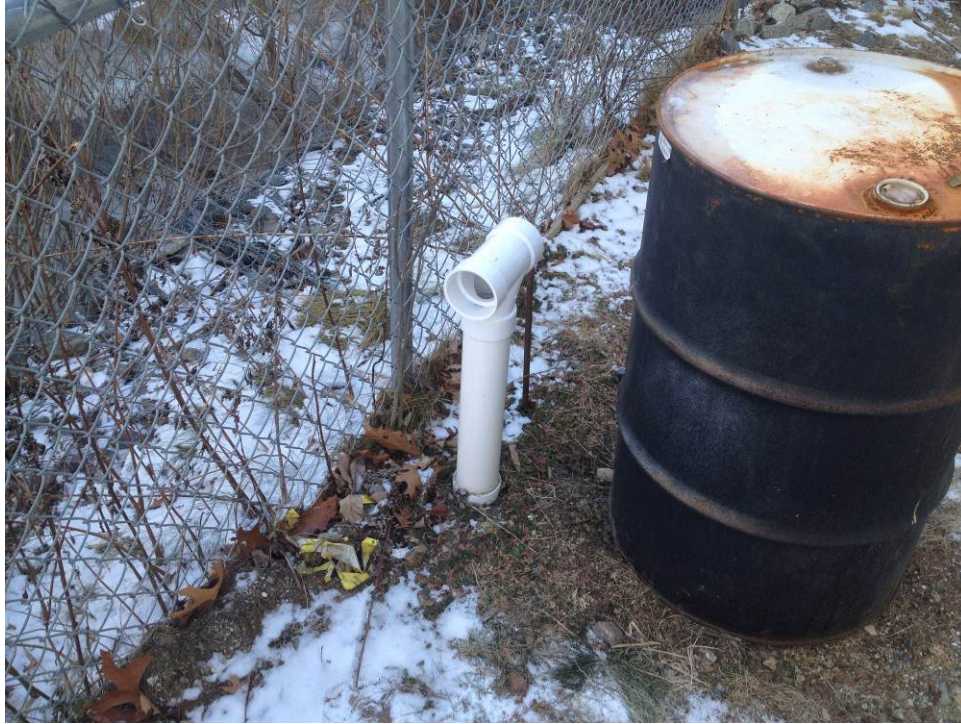
SCENE: View of a T-shaped polyvinyl chloride (PVC) pipe located on the western side of the Quality Automatics, Inc. building.

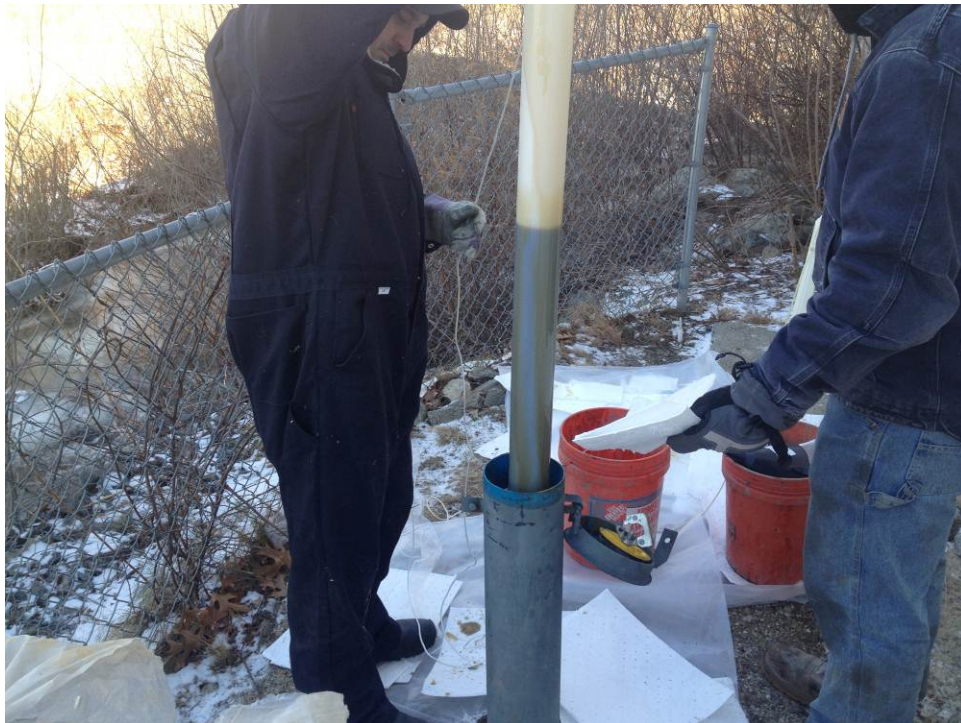
SCENE: View of product and water being bailed out of the on-site monitoring wells to observe the recharge rate of the wells.

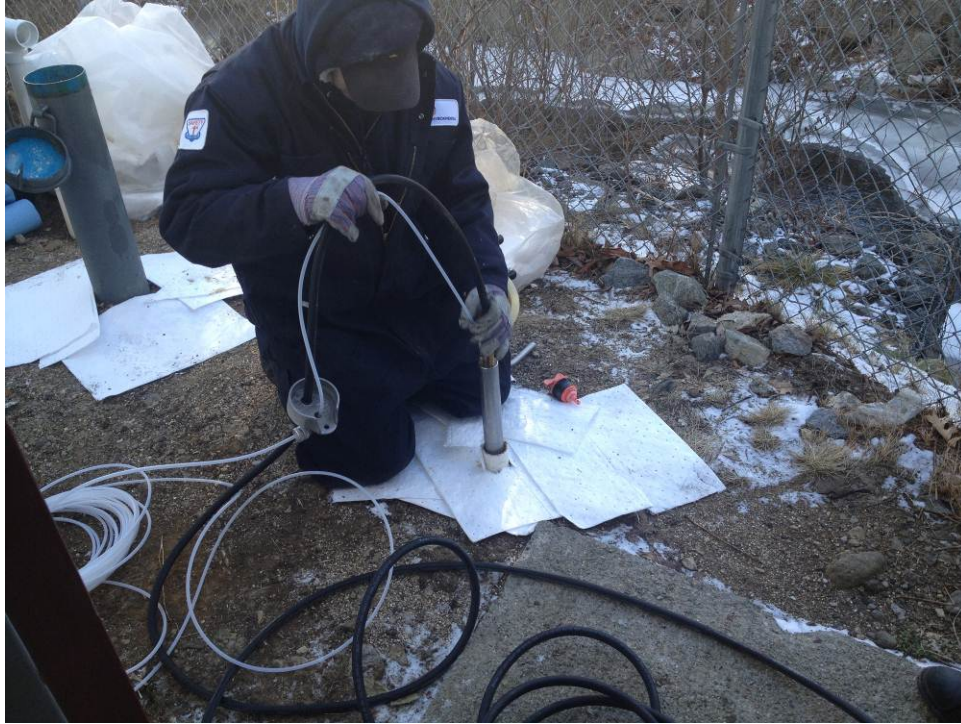
SCENE: View of the GeoTech SpOILer Controless Recovery Pump being installed into monitoring well MW-6.

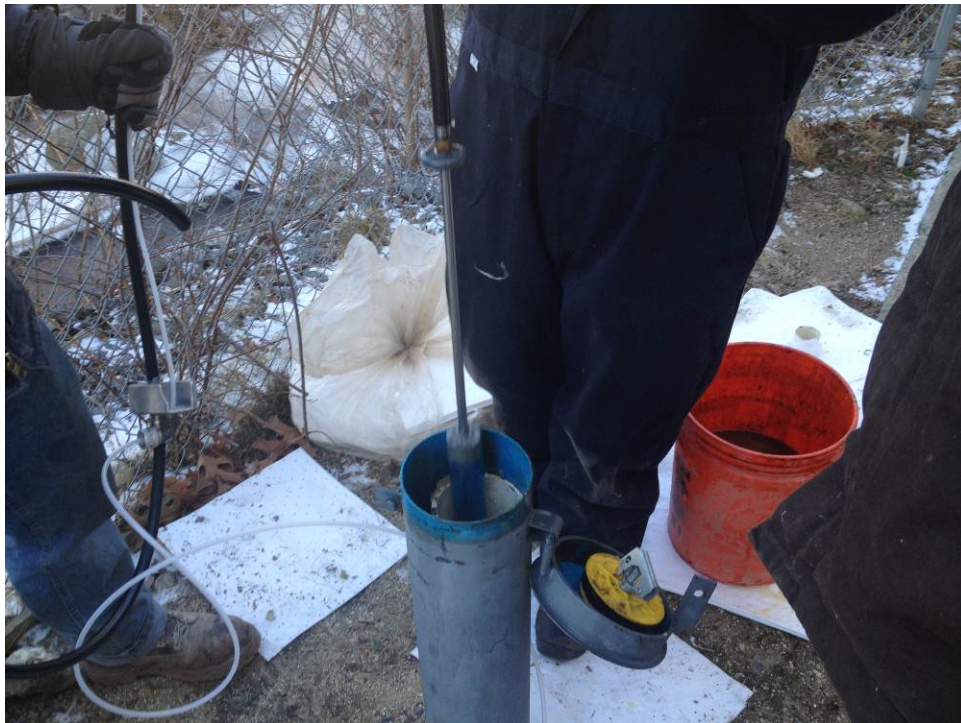
SCENE: View of the GeoTech SpOILer Controless Recovery Pump being installed into monitoring well MW-05.

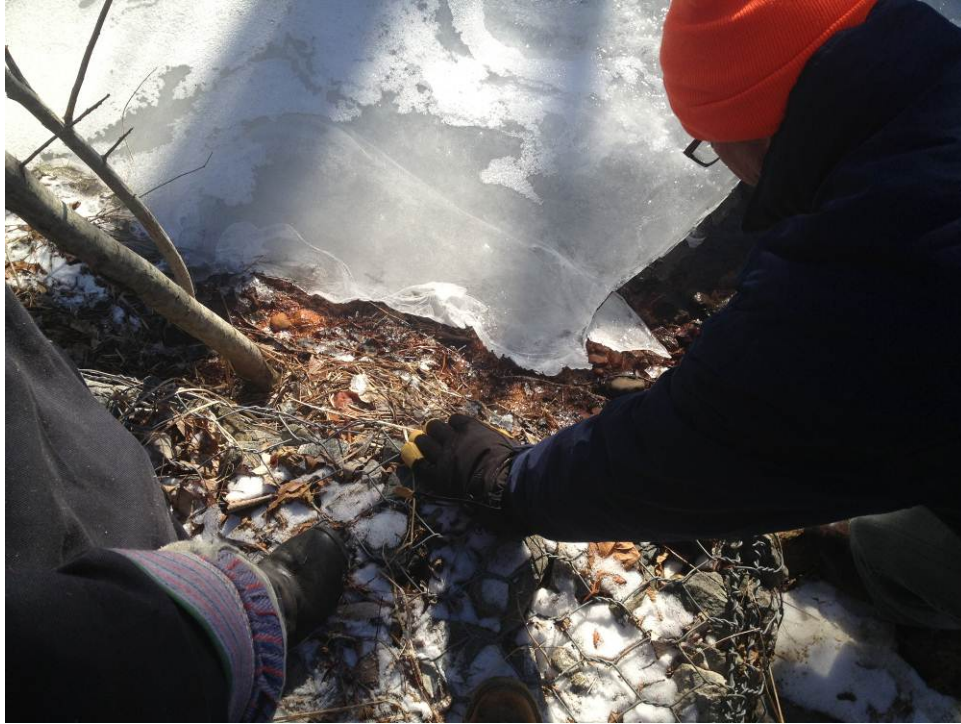
SCENE: View of personnel inspecting areas on northern banks of Turkey Brook, upstream of the spill area at the Quality Automatics, Inc. building.

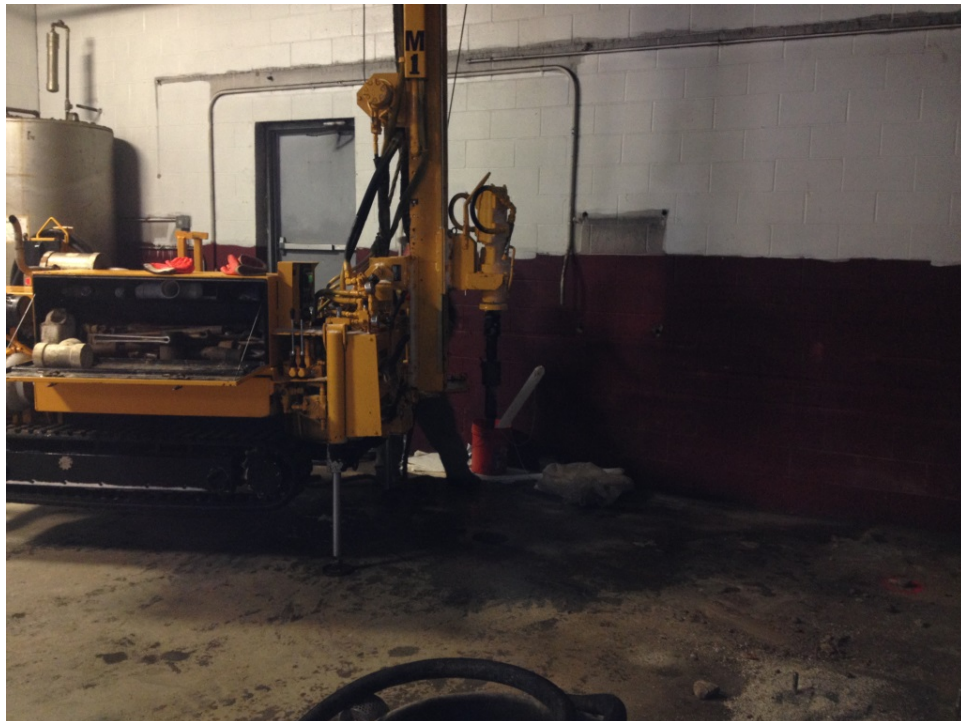
SCENE: View of the drill rig staged and being prepared to advance borings inside the QAI building.
